**GEOTECHNICAL INVESTIGATION OF CAUSES OF ROAD FAILURES IN
IKOLE AREA**

**A PROJECT SUBMITTED TO THE DEPARTMENT OF CIVIL ENGINEERING,
FEDERAL UNIVERSITY OYE EKITI IN PARTIAL FULFILLMENT OF THE
REQUIREMENTS FOR THE AWARD OF THE B. ENG. (HONS) IN CIVIL
ENGINEERING.**

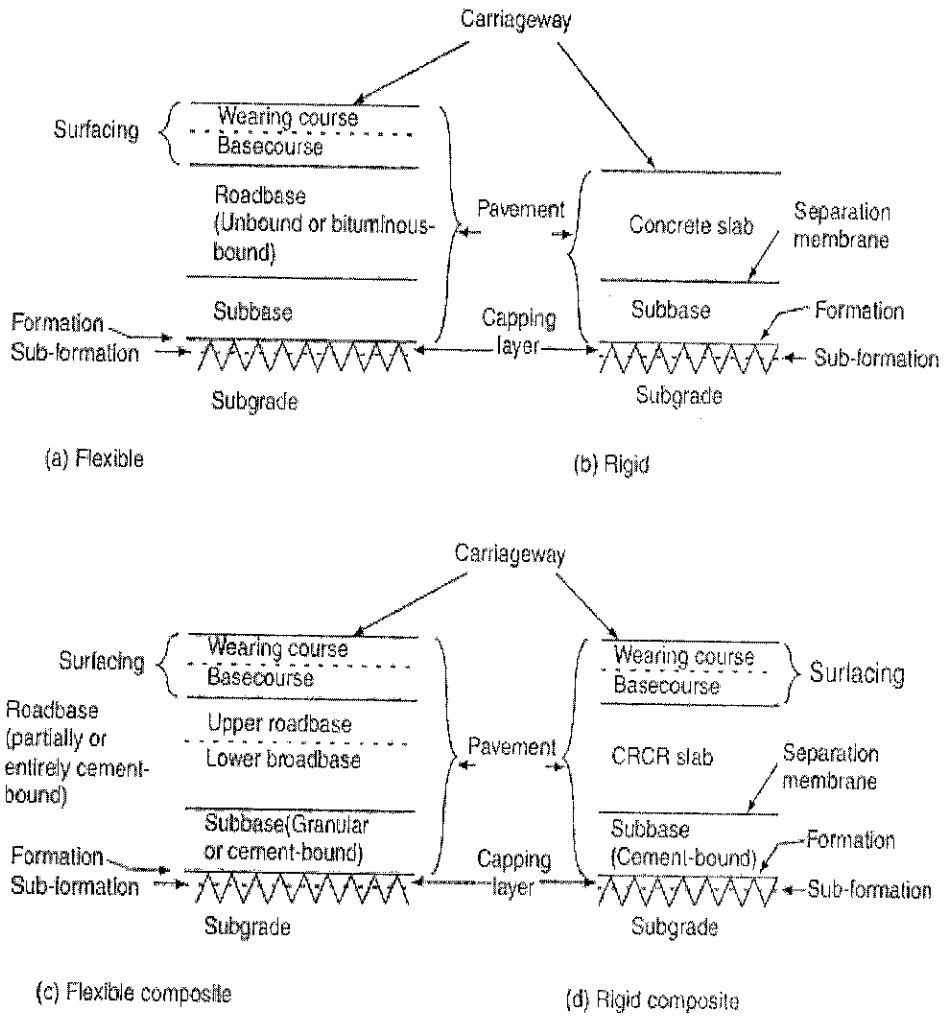
Modern pavement design is concerned with developing the most economical combination of pavement layers that will ensure that the stresses and strains transmitted from the carriageway do not exceed the supportive capacity of each layer, or of the subgrade and it can withstand the action of the climate with minimal deterioration during the design life of the road. Major variables affecting the design of a given pavement are therefore the volume and composition of traffic, the subgrade environment and strength, the materials economically available for use within the pavement layers, and the thickness of each layer. For discussion purposes, pavements can be divided into two broad types; flexible pavements and rigid pavements (see Fig 2.1).

Figure 2.1 Basic Elements of Flexible and Rigid Types of Pavement

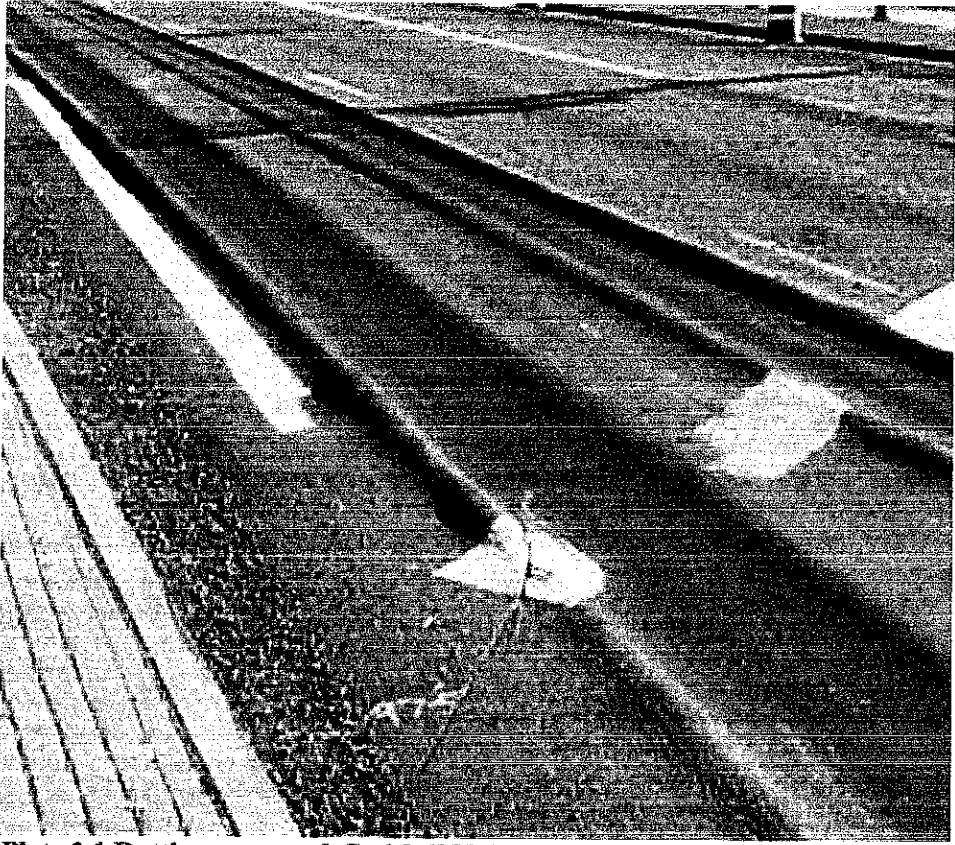
- v. Faulty laying of surface course
- b) **Rutting:** This is the longitudinal deformation or depression of the pavement surface along the wheel path of heavy vehicles formed due to repeated applications of heavy load along the same wheel path resulting in cumulative non-recoverable or pavement deformation of the pavement layers including subgrade and one or more of the pavement layers. The various causes of rutting may be summed up as;

Plate 2.1 Rutting on a road, Smith (2004)

- v. Cleaning the affected surface
 - vi. Application of tack coat and covering the ruts
 - vii. Filling the ruts using either a dense graded bituminous mix or open graded pre-mix followed by seal coat

- viii. Compaction by rolling
 - ix. Providing a thin bituminous resurfacing course to achieve good riding quality.

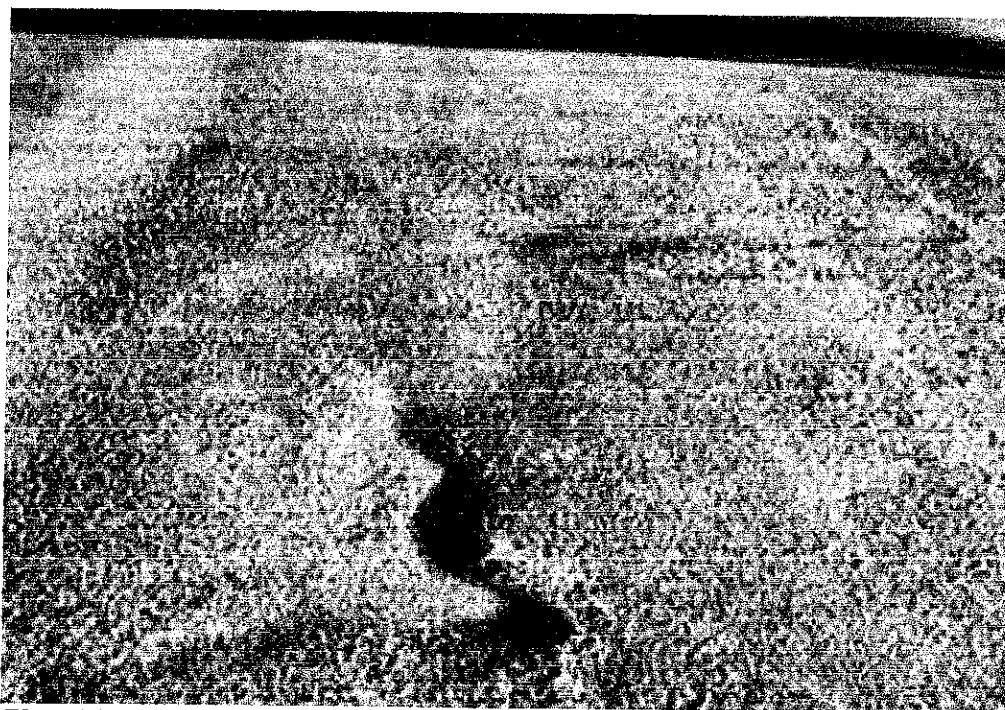
- c) **Shoving:** Shoving is a form of plastic movement resulting in a localized bulging of the pavement surface. Shoving can take a number of different forms such as upheaval, “wash boarding” or ripples across the pavement surface, or even a crescent –shaped bulging.

Plate 2.2 Shoving on a trafficked road, (Smith, 2004)

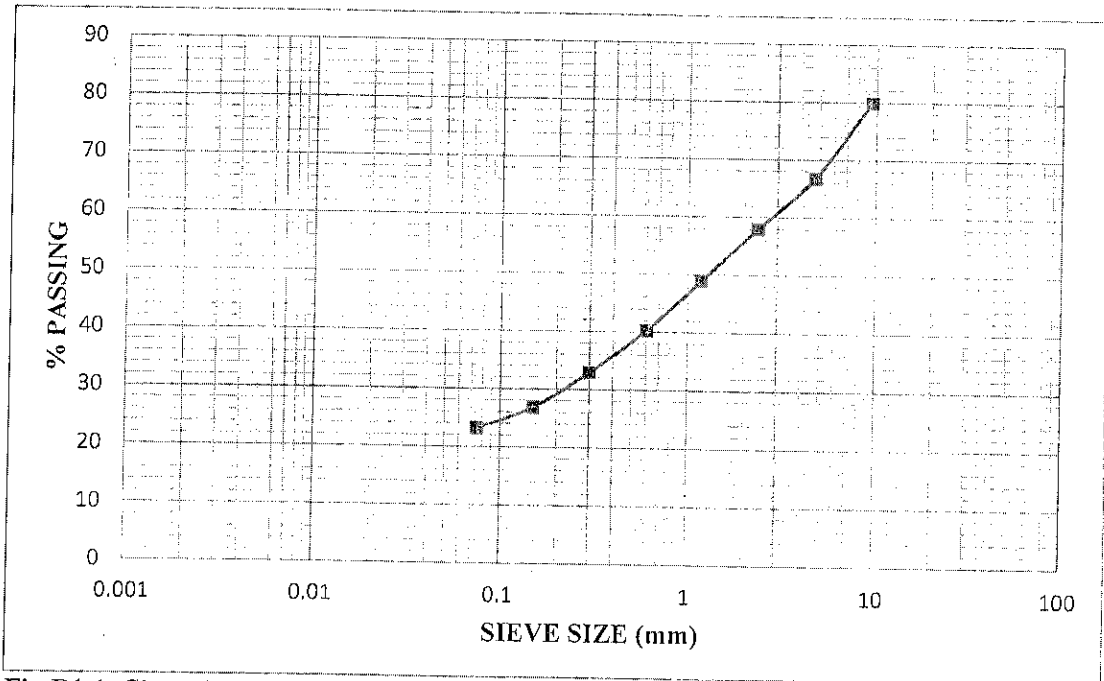
Fig B1.1: Sieve Analysis Graph for Sample A

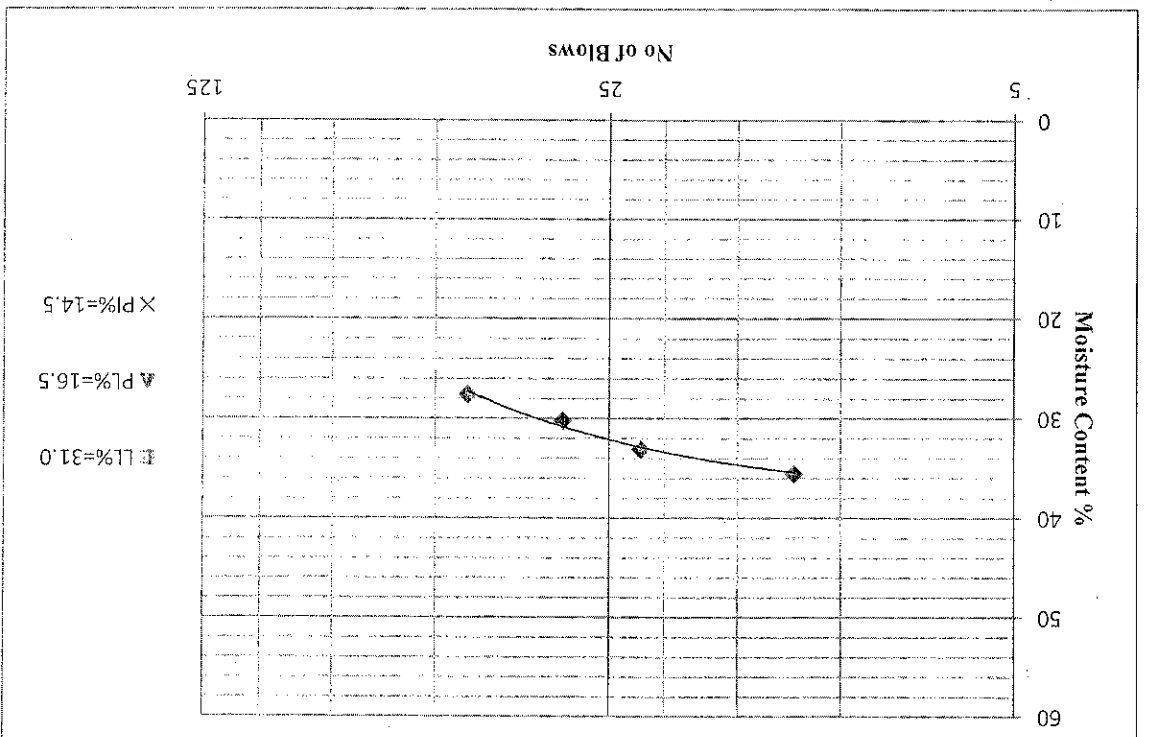
Fig B4.4: Atterbergs Limit Graph for Sample D
